Service Bulletin

File GE-10-118

Subject ESA-569 Clutch Plate Super 55

Date 11-16-84

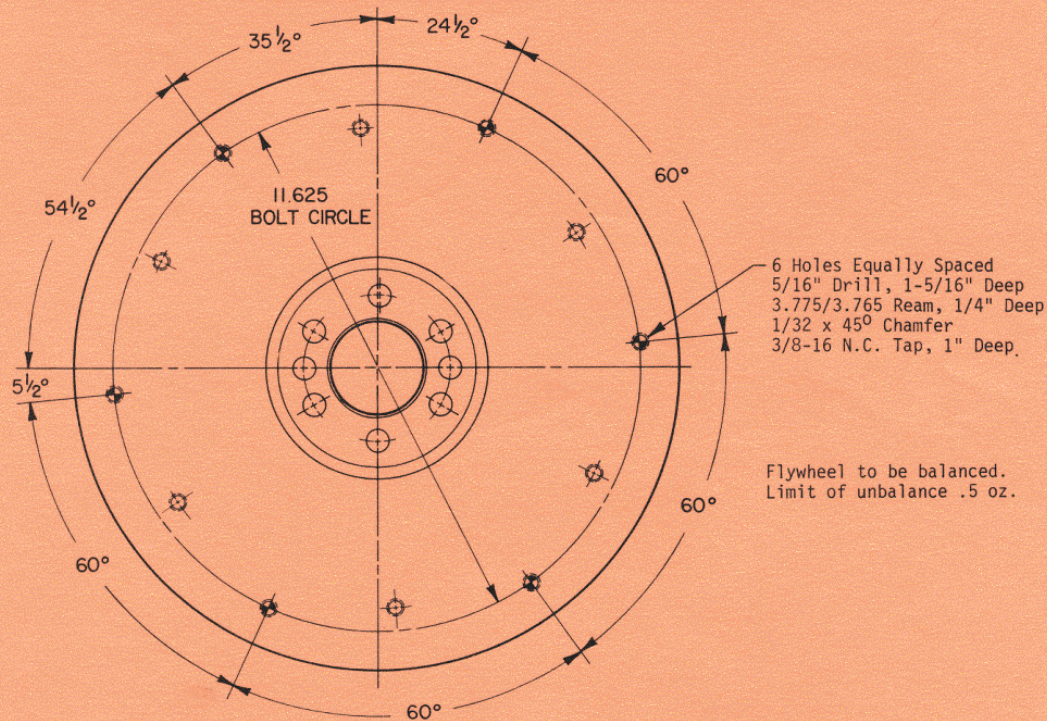
In order to install larger 100 691AS Clutch Plate Assembly, flywheel must have 6 3/8-16 tapped holes in a 11.625 inch bolt circle.

If flywheel does not have these holes to accept new 10-inch clutch, flywheel must be reworked (Fig. 1) or replaced with flywheel that has 11.625 inch bolt circle.
