Service Bulletin

LOCATION Charles City
SUBJECT PTO Drive Shaft Plug
NUMBER 430 228
DATE 9-14-68
FILE D & E PTO & Pulley

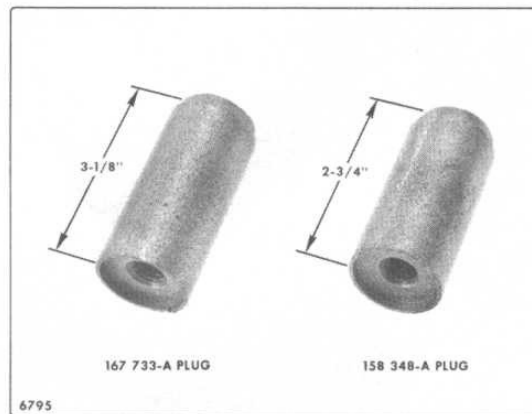
Fig. 1 PTO Drive Shaft Plug

PTO shaft plug can be too short on some 1750, 1850 and 1950-T tractors. Problem is common only to those tractors equipped with button-type clutch.

With PTO shaft plug being too short, plug can move forward of O-ring and oil leakage results.

At approximately tractor serial number 207 334-000, 3/8-inch longer 167 733-A PTO Drive Shaft Plug was incorporated on production 1750, 1850 and 1950-T Tractors replacing 158 348-A PTO Drive Shaft Plug.

When PROBLEM is encountered on tractors with button-type clutch, 167 733-A PTO Drive Shaft Plug may be purchased and installed. Following list of approximate tractor serial numbers indicates when button-type clutch was incorporated on production tractors:
