White Farm Equipment Company

Service Bulletin

Location Charles City
 Subject Transmission Oil Leakage –
 1265 & 1365 Tractors
 Number 430 713
 Date 5-8-75
 File C Transmission

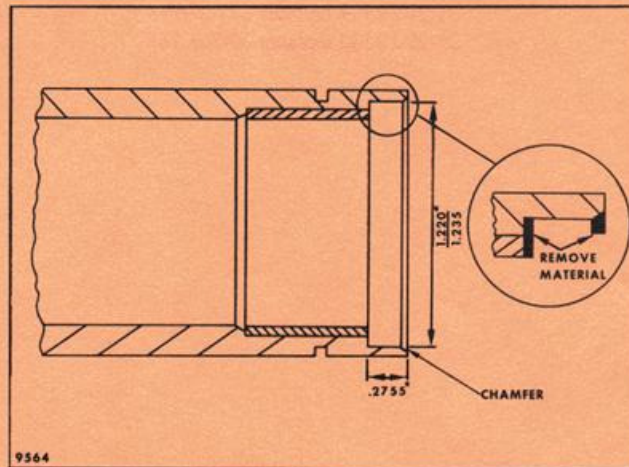
Fig. 1. Upper Transmission Shaft

Transmission oil may travel forward along PTO shaft to engine clutch on some 1265 and 1365 tractors.

677 412A Seal may allow transmission oil to move forward along PTO shaft or seal may turn with PTO shaft permitting oil seepage between seal and transmission input shaft.

Existing 677 286AS (1265) and 30-301 1690 (1365) shafts may be reworked to accept 31-290 2578 Seal (Fig. 1). Install seal with lip toward rear of tractor.

NOTE: If seal does not fit securely in bore, secure using sealant or 30-316 3253 Loctite (No. 271).

If upper transmission shaft requires replacement, install following shafts which use 31-290 2578 Lip Type Seal.
