White Farm Equipment Company

Service Bulletin

Location Charles City
Subject Transmission –
1365-1370 Tractor
Number 430 740
Date 8-6-75
File C Transmission

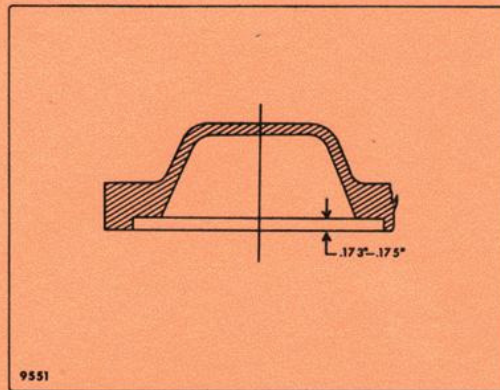
Transmission may jump out of 2nd and 4th gear on some 1365 and 1370 tractors.

670 228A Cover may be machined incorrectly. Cover should clamp lower shaft bearing and gasket simultaneously. As gasket is crushed lower shaft is forced to rear until snap ring contacts case preventing lateral movement of shaft. If 670 228A Cover has excessive counterbore, shaft is allowed to move forward with resulting gear disengagement.

If problem exists, remove 670 228A Cover and check cover as shown in Fig. 1. If counterbore exceeds .173-.175-inch in depth, purchase and install 670 228A Cover or mill existing cover to specification.
