## Service Bulletin

Location Charles City  
 Subject Transmission –  
 1265-1270 Tractors  
 Number 430 741  
 Date 8-7-75  
 File C Transmission

This bulletin supersedes and cancels bulletin 430 698 dated 2-18-75 to provide additional information relating to transmission gear disengagement on 1265-1270 tractors.

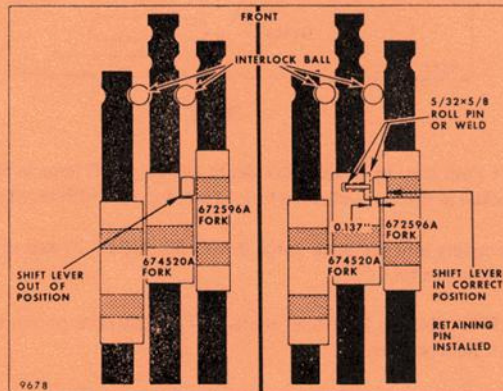
Fig. 1.

1. Three conditions may contribute to disengagement of 1st and 4th gear.
  - a. 672 416A Interlock Ball for 674 520A Hi-Low Range Shift Fork may have been left out at assembly. Interlock ball locks center rail in position which in turn is used to lock transmission in gear with end of shift lever (Fig. 1).

- b. Notch in 674 520A Shift Fork may be of excessive depth allowing shift lever to move out of position (Fig. 1). 672 596A Fork will not be locked in position, allowing fork to move to rear with resultant gear disengagement.
- c. End of shift lever not dropping into interlock notch in 674 520A Fork or end of shift lever and/or notch in fork worn so lever does not lock in position.
2. Excessive material on 672 596A Shifting Fork may contact 672 492A Gear preventing complete engagement of 671 123A Gear with 31-290 2114 Reverse Gear.
3. 670 228A Cover may be machined incorrectly. Cover should clamp lower shaft bearing and gasket simultaneously. As gasket is crushed lower shaft is forced to rear until snap ring contacts case preventing lateral movement of shaft. If 670 228A Cover has excessive counterbore, shaft is allowed to move forward with resulting disengagement of 3rd and 6th gear.

Drill 5/32-inch hole approximately 1/2-inch deep and install 933 165 Roll Pin (5/32 x 5/8-inch) (Fig. 1). Use care to catch all shavings while drilling hole in fork. CAUTION: Pin must leave 0.137-inch (3.5 mm) notch (Fig. 1).
